Radlett Road Recreation Ground

River Improvement Plan

**WATFORD
BOROUGH
COUNCIL**

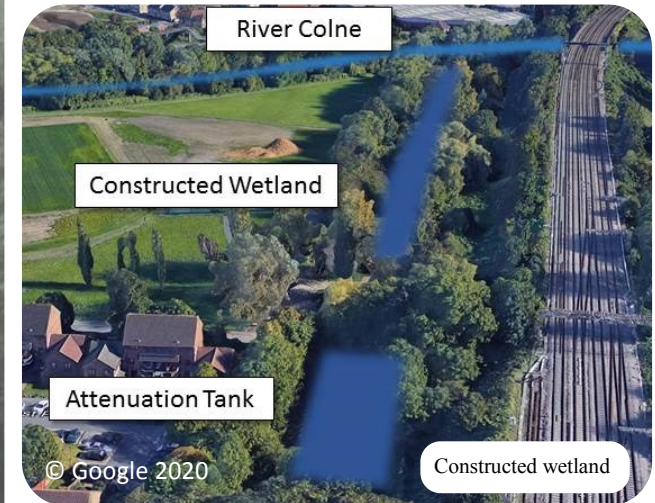
A constructed wetland feature lies to the South of the floodplain and drains towards the main river from the east of the site. The feature was constructed in the 1990s in order to attenuate surface water run off from the surrounding urban area before being discharged to the River Colne. The wetland receives water from a Thames Water attenuation tank located to the North of the Radlett Road that was originally designed to separate grit and oil from road run off. Since the creation of the feature the surface water catchment area has grown and the number of properties with sewage misconnections has increased. This has resulted in a greater quantity of water and increased levels of pollution entering the constructed wetland. Today, the feature is in need of urgent management and could be redesigned to improve both

habitat for wildlife and the settlement of surface water before being discharged to the River Colne.

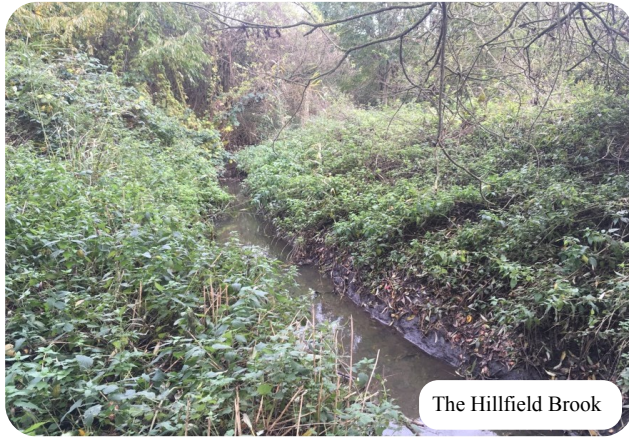
To the North of the site, The Hillfield Brook flows in a westerly direction across the floodplain before meeting the River Colne. The brook flows from Hillfield Reservoir and through the area of Bushey before reaching the site via a culvert beneath the Stephenson's Way. The brook has a straightened profile and receives both urban and rural run off from the surrounding landscape. After times of heavy rainfall, plumes of sediment can be regularly observed at the confluence of the brook with the River Colne, illustrating that the watercourse can be a significant source of siltation of the main river. Invasive species are also present, with Japanese Knotweed and Himalayan Balsam observed at the time of survey.

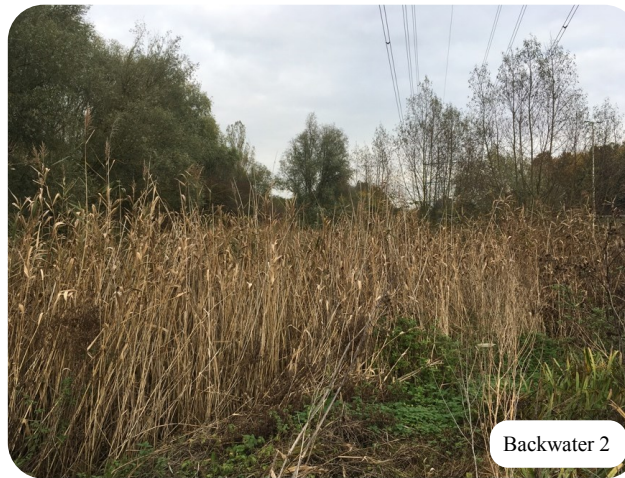
Backwater 2

A second backwater, created as part of the 1996 restoration scheme, is also present and is in a different

phase of succession to the first. Common reed can still be observed in the feature, but due to lower water levels and the effects of siltation, the species has now expanded over the entire bed of the pond. This illustrates the backwater is much dryer than it used to be and will reach a similar stage of succession to its counterpart over the next five years unless intervention is made to restore the feature. The inlet channel of the backwater is now blocked with sediment and trees and does not provide a constant connection with the main river, although connection still occurs when the backwater is inundated with water during peak flows.

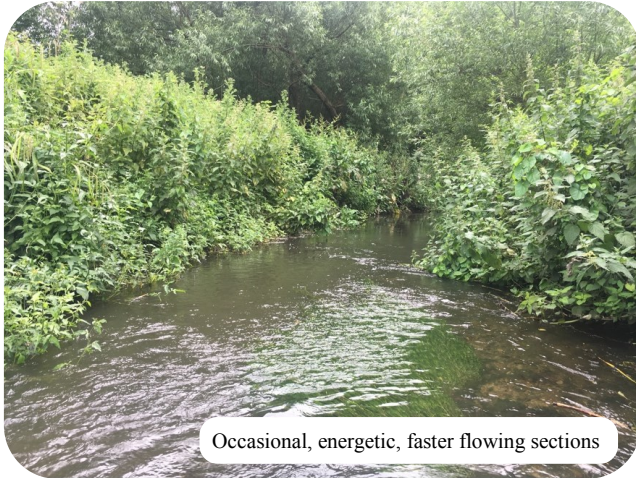
Occasional, energetic, faster flowing sections

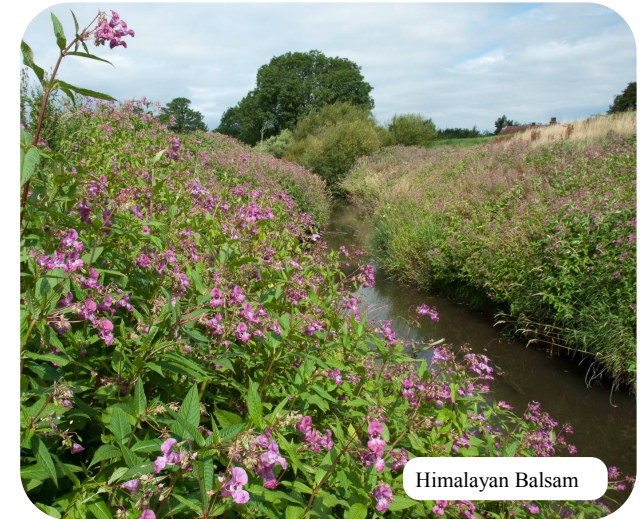
Himalayan balsam is present throughout the river channel on site, but does not dominate over native species due to diligent regular management from the Knutsford Green Gym volunteer group. If the regular management were to cease, Himalayan balsam would rapidly recolonize and spread throughout the site. Small patches of Japanese Knotweed are also present throughout the river corridor. The site should be surveyed for invasive plant species each year using the CVFC invasive species reporting application and management works carried out accordingly.

1. Eradicate the Himalayan Balsam by constant pulling during summer months.
2. Continue to treat stands of Japanese Knotweed on an annual basis.
3. Introduce mink monitoring rafts within the river. These should be sited away from public areas to avoid disturbance.
4. Regularly remove litter from the watercourse with local volunteers.

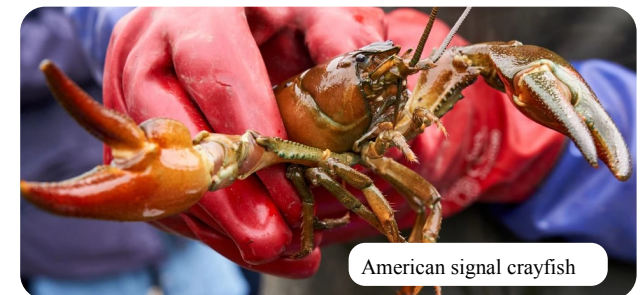
American signal crayfish burrows were found throughout the site. The species is common place in the Colne Catchment. Crayfish Burrowing mobilises sediment which has a negative impact on both water quality and habitat. If deemed a priority, the species should be monitored via the Rediscovering the River Colne Environmental Monitoring Project.

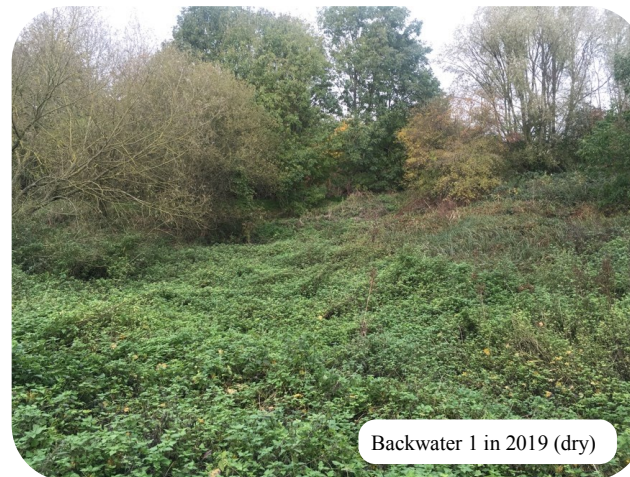
Backwater 1 in 2019 (dry)

Immediately to the south of the brook is a former backwater that was created as part of the NRA's restoration scheme in 1996. The backwater was originally designed to have a constant connection with the main river and to provide valuable refuge for juvenile coarse fish. The feature was planted with common reed which provided good habitat for a range of bird species, fish and freshwater invertebrates. Today the backwater no longer has a constant connection with the main river and has become silted and dry over time. The majority of the reed bed habitat has now been succeeded by nettle and bramble scrub. The feature remains dry throughout most of the year, but is inundated with water from the main river during peak flows, illustrating that the feature's main function is now to relieve fluvial flooding.

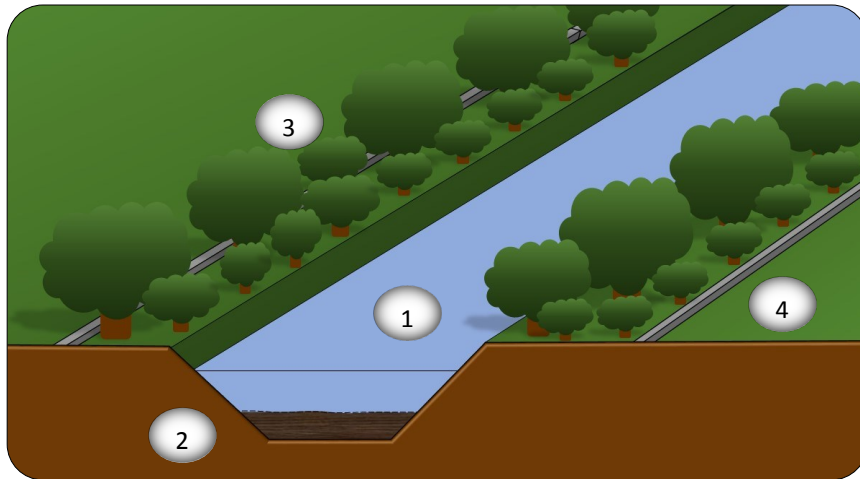
Before Enhancement

1. Surface water flows from an attenuation tank into the wetland and then on to the River Colne via an outfall. Due to the straightened nature of the channel, water quickly reaches the river, leaving little time for natural water filtration to occur.
2. Silt, organic detritus and sewage rag has accumulated in the wetland over time, reducing its water storage capacity and value to wildlife.
3. A thick tree line shades the wetland, preventing diverse plant communities from establishing. The steep gradient of the banks also contribute to this.
4. A fence line blocks access to the wetland meaning that it cannot be accessed or maintained easily.

1. The tree line is thinned and fence line removed to increase light levels and to allow access for maintenance/construction.
2. The wetland is desilted to increase its water storage capacity. Excavated materials are used to create a series of bunds of descending height to separate the wetland into three ponds that cascade into each other as water levels rise, thus slowing conveyance and allowing water to be stored for longer. The water level of each pond can be set either by the height of each bund or by installing outlet pipes at descending levels.
3. The bed of the wetland should be dressed with gravel where appropriate and common reed introduced to each pond to aid natural water filtration.
4. The banks of the wetland should be scalloped/regraded to encourage diverse plant communities to establish.

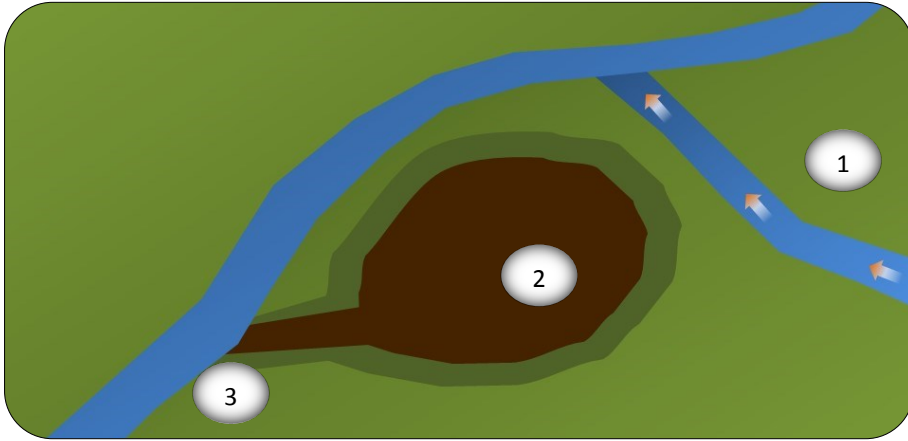
Before Restoration

1. The Hillfield Brook currently flows past the former backwater and into the River Colne. The brook brings surface water run off to the river from both urban and rural areas, which can contain high loadings of fine sediment and contaminants associated with urban pollution.
2. The former backwater is currently disconnected from the main river due to the accumulation of organic debris and silt. The backwater only fills with water during periods of high flow and does not provide refuge habitat for aquatic wildlife.
3. The outlet channel is currently blocked with silt and willow trees.

1. The bed level of the pond and outlet channel is lowered to match the bed level of the adjacent river channel. This will provide a constant connection between the main river and backwater area and will allow aquatic wildlife to ingress/egress at all times. Any trees blocking the outlet channel are removed.

2. The Hillfield Brook is rerouted to flow into a silt trap (a small pond of decent depth) before flowing into the backwater area. The silt trap will be easy to maintain and sediment should be removed every few years by hand, machine or other methods such as using siltex. The constant supply of water to the feature will ensure that it does not dry out again.

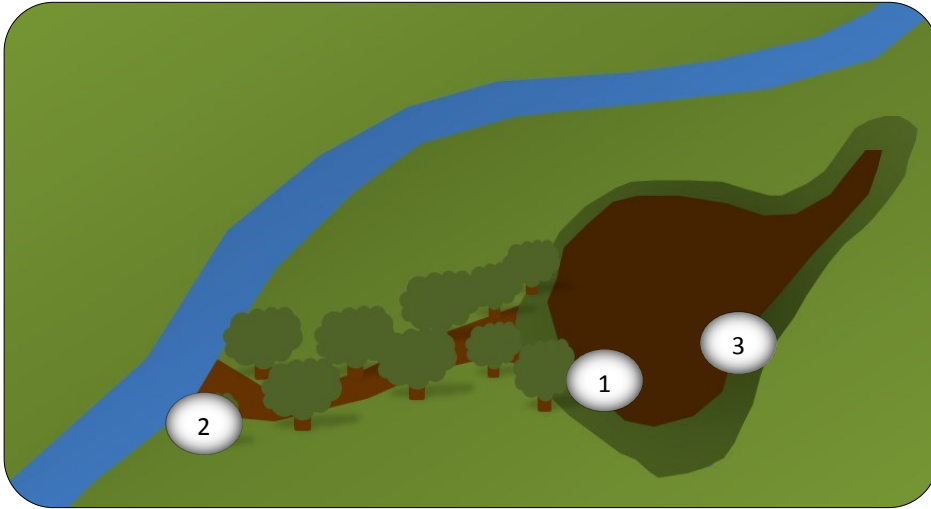
Before Restoration

1. The backwater is currently disconnected from the main river due to the accumulation of organic debris and silt in the pond area and outlet channel.
2. The outlet channel is impeded further by the presence of willow trees that block its connection with the pond area.
3. A reed bed has encroached over the area where the old pond was present but is slowly drying out as the feature is dry for most of the year.

1. The bed level of the pond and outlet channel is lowered to match the bed level of the adjacent river channel.
2. Water is able to back up the channel from the main river, providing a constant connection between the two features.
3. A marginal shelf is created at the edge of the pond which is planted with common reed retained during construction and other native aquatic plant species.
4. The reedbed is to be cut on rotation, annually, to maintain the balance between vegetated areas and open water.
5. If a connection with the river cannot be facilitated, the pond should be enhanced in isolation from the main river.

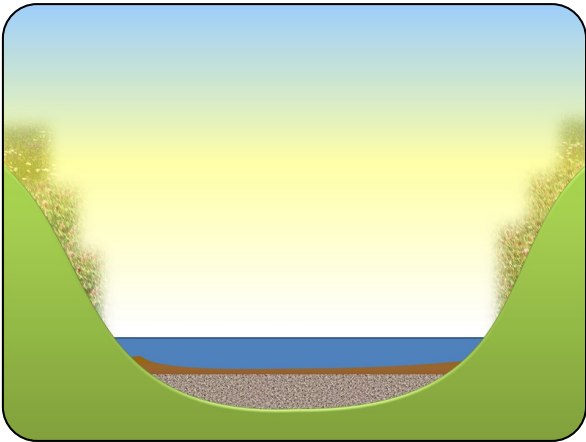
The river channel has a modified profile and uniform depth. Siltation occurs in over shaded areas where emergent plant species are not present to stabilise loose silt in the margins of the river.

Over shading trees can be coppiced and repurposed to create brush berms and flow deflectors within the channel to mimic natural sinuosity, stabilise sediment and to create a variety of depths and flow types.

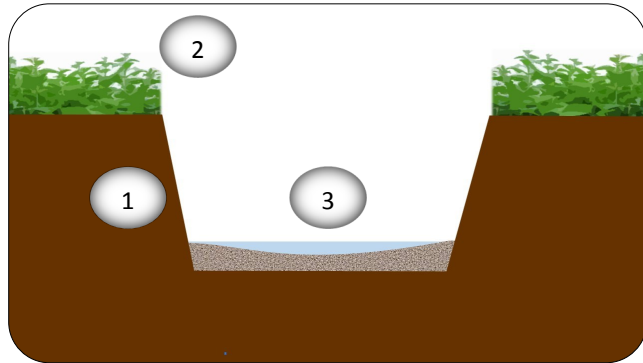
Before Enhancement

1. The banks of the ditch network are often too steep to allow marginal plant life to establish.
2. The bank top is often dominated by stinging nettles and invasive species.
3. The ditch network does not retain water during dry times of year, meaning that it cannot be utilised by aquatic wildlife.

1. Steep banks are regraded to enable a wider diversity of plant species to establish and allowing wildlife safe ingress/egress to the ditch network.
2. Invasive species are managed annually to prevent them taking over the ditch network and migrating towards the main river. An array of native plant species may be introduced if required.
3. Wooded debris, in the form of leaky dams, are placed in key locations throughout the ditch network in order to allow it to retain water for longer periods of time.
