Radlett Road Recreation Ground

River Improvement Plan

**WATFORD
BOROUGH
COUNCIL**

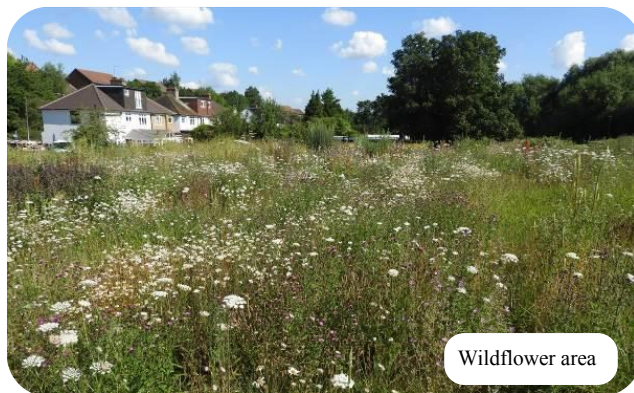
Wildflower Area

There is a notable exception within the amenity area, where there is a curious patch of rank wildflower grassland in the north-west corner. This area looks to have been seeded with a wildflower mix and has some botanical interest with Common Knapweed, Wild Carrot Common Mallow, Weld, Mugwort, Creeping Thistle and Bird's-foot Trefoil evident. Consequently some ruderals have also colonised the area and a diverse botanical community with a complex structure has been created. This is a nice feature but needs managing if it is not to be lost to scrub, as is happening at the moment.

The only other area where enhancement is recommended within the playing fields is the wildflower area to the north-west of the site. This area should be managed annually with the following actions undertaken:

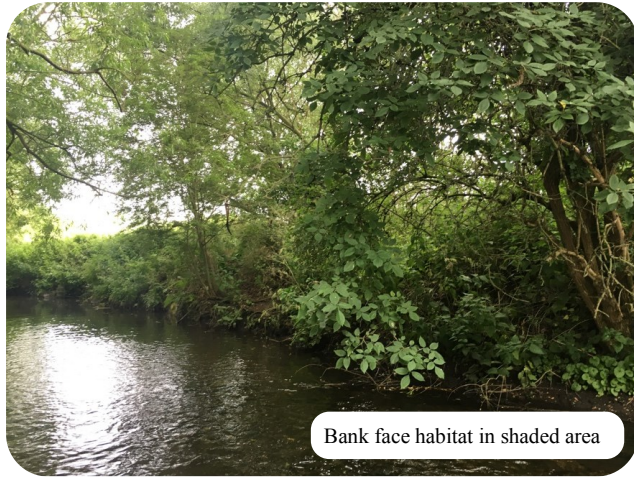
The majority of the river bank receives a high degree of shading from dense tree cover in the riparian zone, which limits the diversity of marginal plant life that is able to establish. The riparian zone is largely comprised of Crack Willow, White Willow and Ash

with less frequent examples of Hawthorn, Dogwood, Crab Apple, Domestic Apple and Elder, both planted and self-set. The banks of the river are largely dominated by stinging nettle throughout the shaded zone, with less frequent examples of fern, dock and lichen species.

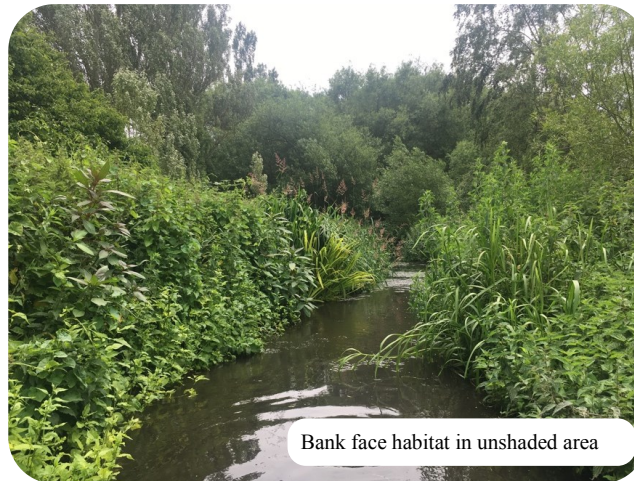
A higher diversity of plant species is present in the few areas with less tree cover. Towards the centre of the site an open, non-shaded area of river is present which illustrates the diversity of plant species that could be achieved with an appropriate ratio of light and shade. The banks of the river in this location are populated with pendulous sedge, greater pond-sedge, great willowherb, reed sweet-grass, gypsy-wort, water mint, butterbur, reed canary grass, common reed, common club-rush and yellow flag iris. It is also worth noting that the width of the river has been significantly narrowed where emergent vegetation is present, which has worked to stabilise sediment, providing bench and berm features at the

toe of the river bank.

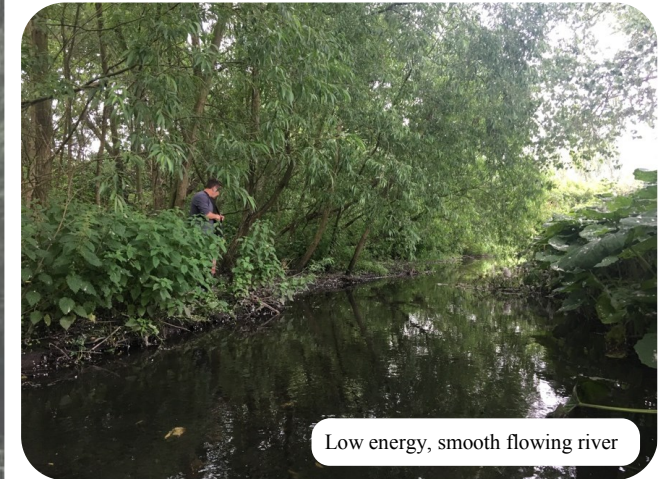
River Bed Habitat, Substrate and Flow

Throughout the majority of the site, the river is a low energy watercourse with a uniformly smooth flow type. There is high variation in the bathymetry of the river bed due to historic modification, with depths ranging from 0.2 meters to over 1 meter. The river's substrate is predominantly comprised of silt with occasional traces of sand and gravel pebble. The dominance of silt substrate reflects that the river has a poor ability to appropriately sort and grade sediment into morphological features and that the river is still recovering from the impact of the channel re-profiling undertaken in 1990. In some areas where the river has been artificially deepened, its substrate is primarily comprised of organic debris, which is gradually raising the level of the river bed as it accumulates. Areas such as these do not provide

favourable conditions for diverse fish and invertebrate populations to thrive. Intervention is required to catalyse morphological processes and to provide a self-sustaining, dynamic water course.

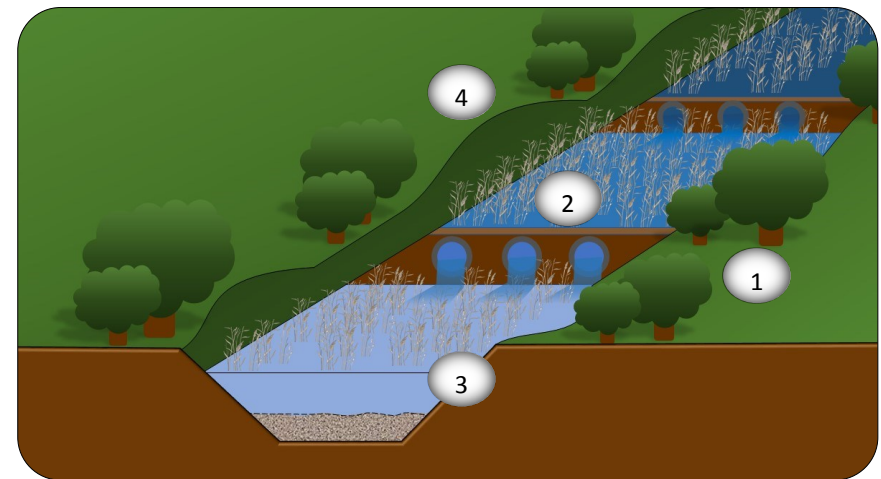
After Enhancement

1. Surface water flows from an attenuation tank into the wetland and then on to the River Colne via an outfall. Due to the straightened nature of the channel, water quickly reaches the river, leaving little time for natural water filtration to occur.
2. Silt, organic detritus and sewage rag has accumulated in the wetland over time, reducing its water storage capacity and value to wildlife.
3. A thick tree line shades the wetland, preventing diverse plant communities from establishing. The steep gradient of the banks also contribute to this.
4. A fence line blocks access to the wetland meaning that it cannot be accessed or maintained easily.

1. The tree line is thinned and fence line removed to increase light levels and to allow access for maintenance/construction.
2. The wetland is desilted to increase its water storage capacity. Excavated materials are used to create a series of bunds of descending height to separate the wetland into three ponds that cascade into each other as water levels rise, thus slowing conveyance and allowing water to be stored for longer. The water level of each pond can be set either by the height of each bund or by installing outlet pipes at descending levels.
3. The bed of the wetland should be dressed with gravel where appropriate and common reed introduced to each pond to aid natural water filtration.
4. The banks of the wetland should be scalloped/regraded to encourage diverse plant communities to establish.

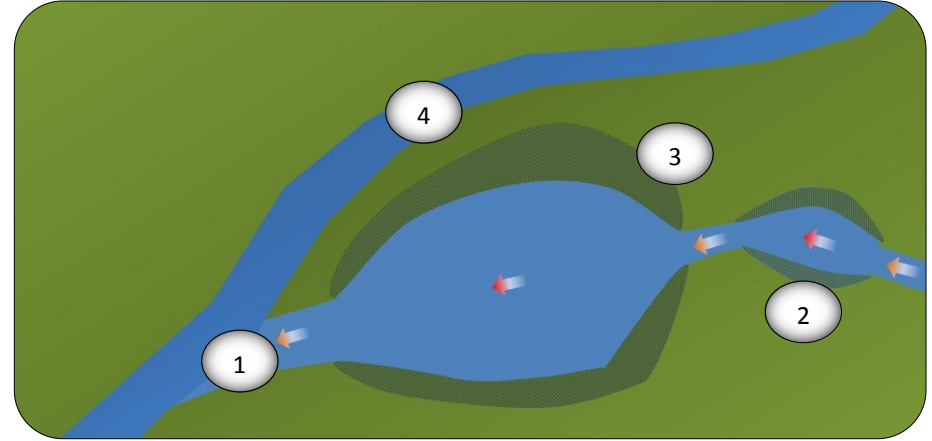
After Restoration

1. The Hillfield Brook currently flows past the former backwater and into the River Colne. The brook brings surface water run off to the river from both urban and rural areas, which can contain high loadings of fine sediment and contaminants associated with urban pollution.
2. The former backwater is currently disconnected from the main river due to the accumulation of organic debris and silt. The backwater only fills with water during periods of high flow and does not provide refuge habitat for aquatic wildlife.
3. The outlet channel is currently blocked with silt and willow trees.

1. The bed level of the pond and outlet channel is lowered to match the bed level of the adjacent river channel. This will provide a constant connection between the main river and backwater area and will allow aquatic wildlife to ingress/egress at all times. Any trees blocking the outlet channel are removed.

2. The Hillfield Brook is rerouted to flow into a silt trap (a small pond of decent depth) before flowing into the backwater area. The silt trap will be easy to maintain and sediment should be removed every few years by hand, machine or other methods such as using siltex. The constant supply of water to the feature will ensure that it does not dry out again.

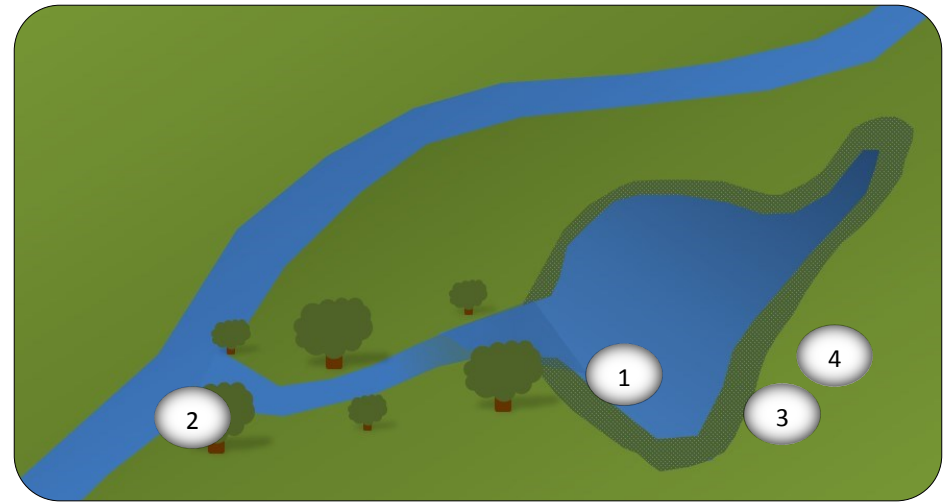
After Restoration

1. The backwater is currently disconnected from the main river due to the accumulation of organic debris and silt in the pond area and outlet channel.
2. The outlet channel is impeded further by the presence of willow trees that block its connection with the pond area.
3. A reed bed has encroached over the area where the old pond was present but is slowly drying out as the feature is dry for most of the year.

1. The bed level of the pond and outlet channel is lowered to match the bed level of the adjacent river channel.
2. Water is able to back up the channel from the main river, providing a constant connection between the two features.
3. A marginal shelf is created at the edge of the pond which is planted with common reed retained during construction and other native aquatic plant species.
4. The reedbed is to be cut on rotation, annually, to maintain the balance between vegetated areas and open water.
5. If a connection with the river cannot be facilitated, the pond should be enhanced in isolation from the main river.

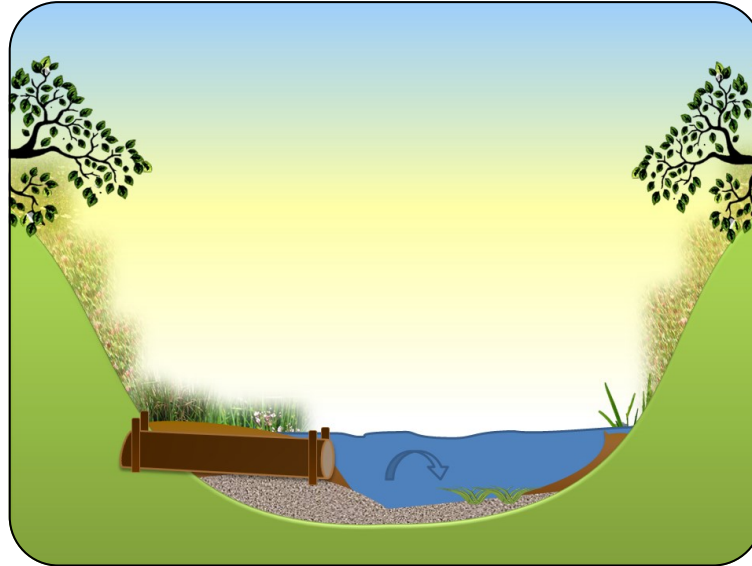
The river channel has a modified profile and uniform depth. Siltation occurs in over shaded areas where emergent plant species are not present to stabilise loose silt in the margins of the river.

Flow deflectors are used to pinch the width of the river which reduces siltation, creates scour and facilitates a variety of different flow types.

They are created by securing tree trunks to the bed of the river with chestnut posts and galvanised steel wire. A pool feature can also be created downstream of each deflector's location to provide a variety of depths. Materials won from excavating pools can be repurposed to create riffles or side bars, which further increase physical habitat complexity.

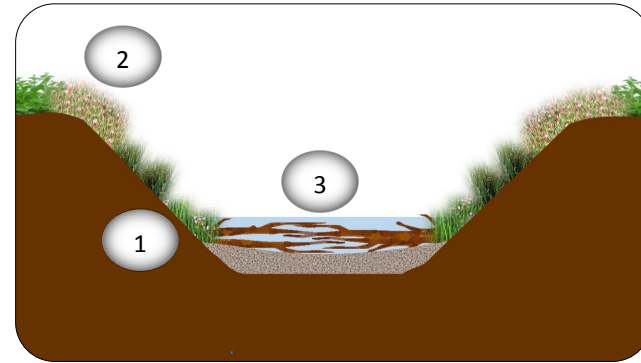
After Enhancement

1. The banks of the ditch network are often too steep to allow marginal plant life to establish.
2. The bank top is often dominated by stinging nettles and invasive species.
3. The ditch network does not retain water during dry times of year, meaning that it cannot be utilised by aquatic wildlife.

1. Steep banks are regraded to enable a wider diversity of plant species to establish and allowing wildlife safe ingress/egress to the ditch network.
2. Invasive species are managed annually to prevent them taking over the ditch network and migrating towards the main river. An array of native plant species may be introduced if required.
3. Wooded debris, in the form of leaky dams, are placed in key locations throughout the ditch network in order to allow it to retain water for longer periods of time.
